# Confidential Inspection Report

4321 Client Street  
Anyplace, MA

Prepared by: Maida Services, Inc.  
P.O. Box 12  
Hampstead, NH 03841  
800-669-3809 [msinc1356@comcast.net](mailto:msinc1356@comcast.net)

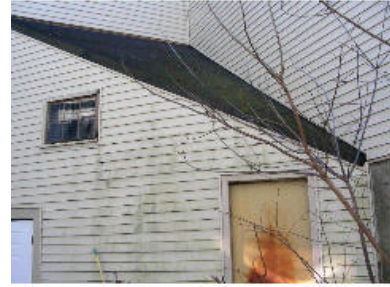
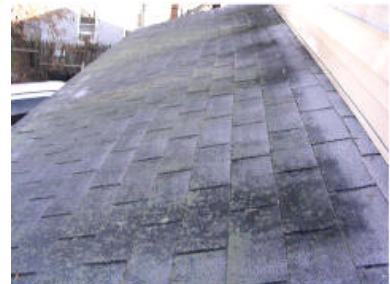
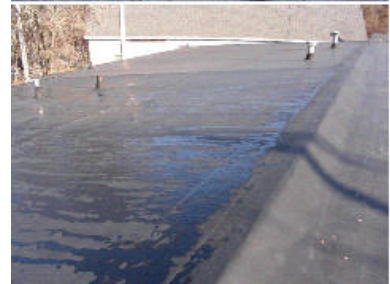
The north side shed roof shows Signs of, Aging, Moss build-up. Roof covering appears fully depreciated, at end of useful life.

The east side shed roof covers a staircase that was blocked inside the laundry service.

This roof shows problems, surface is worn, the roof edges are missing flashings, no overhang. Water appears to be penetrating inside the wall causing wood frame structural problems.

The wall is loose.

Roof covering is in need of replacing. Old shingles should be removed first. Consider consultation with a roofing contractor for cost estimates.

Recommend re-roofing and removing the vinyl siding to properly evaluate and re-build the wall structure.

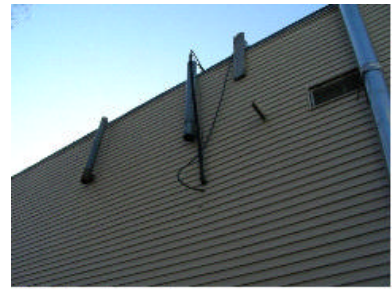
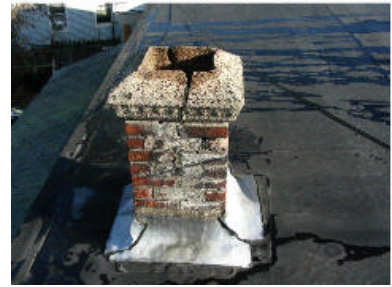
The brick chimney shows some exterior cracks, could use some repair.

All metal chimneys show beginning rust.

There are a few rusted out metal chimneys through the east wall. Recommend their use be determined and replace as needed. Rain caps missing.

One upgraded high efficiency furnace power vents through pvc piping.

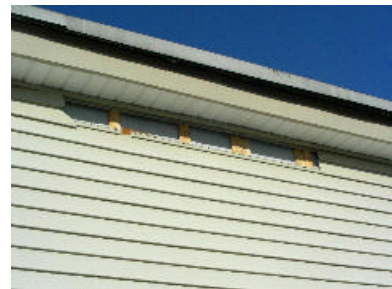
Siding shows some minor damage.  
Siding is in need of some spot repair.

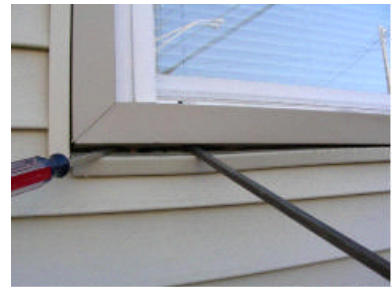
Several door casings show loose trim joints.  
The east side entry door shows wood decay behind the metal trim.  
Recommend removing metal to access the decay and perform repairs.  
Some evidence of older termite damage is a concern.

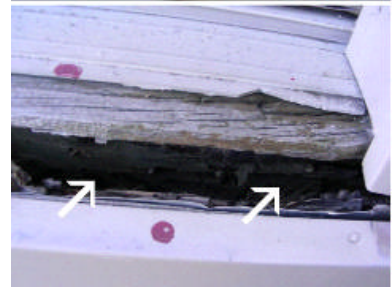
East side windows show some evidence of water penetration and decay.  
Also needs siding removal to perform proper repairs.

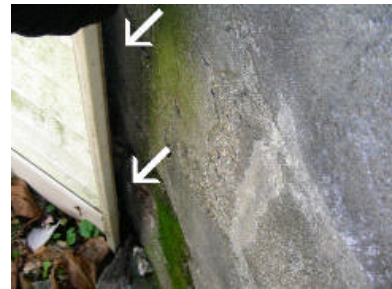
Some improvements to caulking are possible at windows, doors, trim and / or pipes passing through walls.  
The loose east wall at stair enclosure is not tight to the foundation which is probably an access way for rodents.  
Traps and rodents were observed in the basement bowling area.

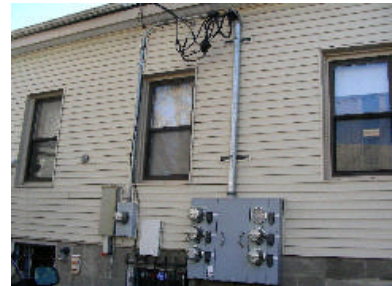
Six metered services supply the five units.  
Exterior shows a recent meter board upgrade.

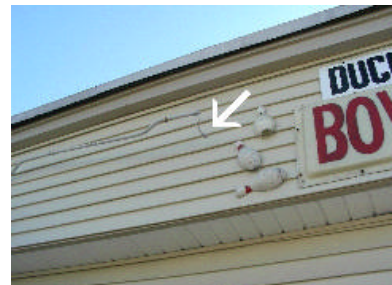
Loose wire needs rear at north side, sign was probably removed.

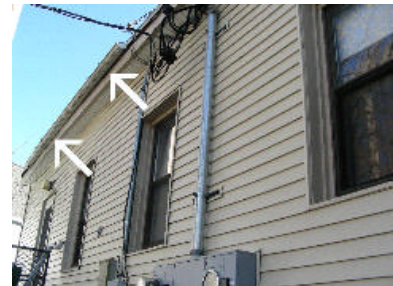
Gutter(s) has: Pulled Away.  
Downspout fell off.  
This gutter above entry ways may have been pulled off by ice dams.  
The attic areas appear poorly insulated allowing rapid heat lose and hot roof problems melting snow to fast into gutters.

Recommend new gutters on north side and an insulation be installed to cool roof and save energy dollars.

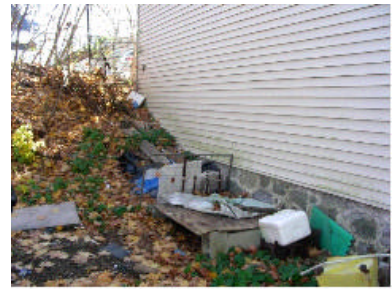
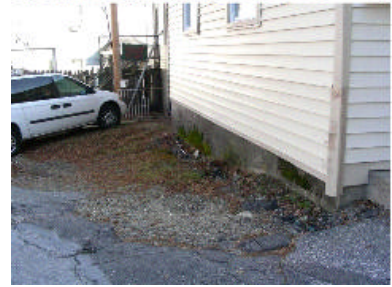
Grading around foundation does not slope away. For proper drainage, recommend sloping grade away from foundation a minimum of 1 inch per foot for 5 feet wherever possible.

Foundation area should be landscaped with good drainage. Soil, mulch and dense vegetation negatively effect the building by holding wetness in and inviting insects and rodents along the foundation, giving them an easy path into the building.

I recommend a foundation apron on the ground, along the foundation to shed water away and reduce the invitation to moisture and pests.

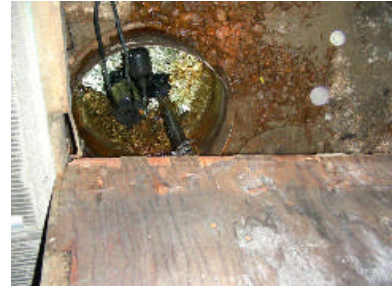
High water tables can flood basements in this area. A sump pump has been installed, should be monitored during flooding weather conditions. Consider purchasing a battery back up system.  
 The quality of installation is poor, recommend sump basin and sump pump be replaced with a more effective system.

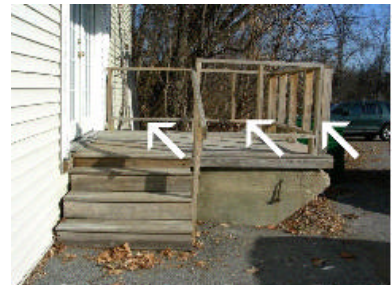
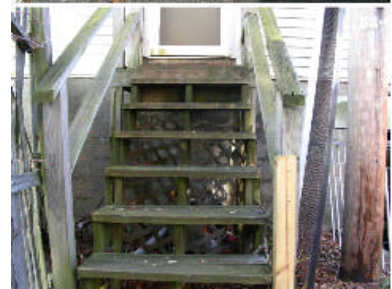
Shows signs of: Wood decay.

Handrail is loose. Recommend repair by a qualified contractor to increase safety.

Guards are too far apart to provide safety and prevent falls. Current standards only allow four inch openings. These are wider apart.

Recommend re-building guard rail systems with vertical ballasters four inches apart. Recommend repair by a qualified contractor to increase safety.

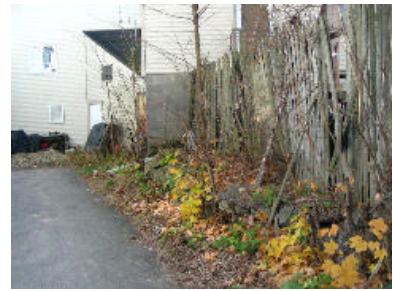
Landscaping and stone wall, fence are all rough. Could use extensive improvements.

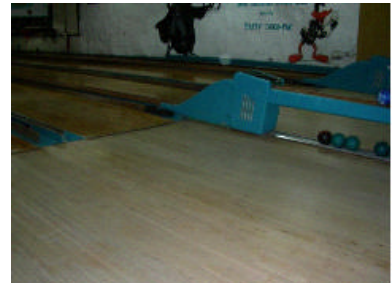
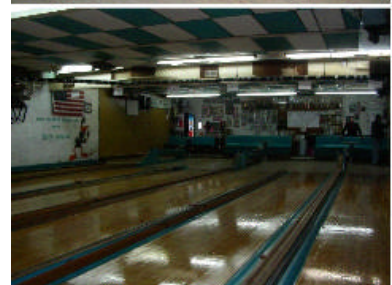
The dirt appears wet, water tables are high. Rising damp is causing some hidden wood decay in my opinion.

The bowling alleys show sagging and some floor frame bounce.

The bowling lanes are not level. The lanes will eventually need to be removed to reveal conditions beneath and to make

proper water control repairs and to probably install a concrete floor.

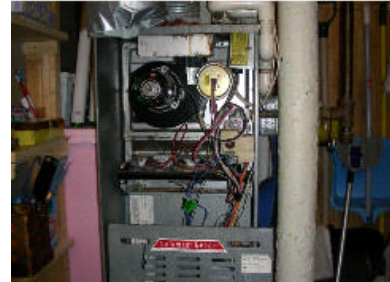
With proper service this furnace should have 5 to 10 years of life left.

Recommend a full service and cleaning of gas burner, furnace and all of the ductwork.

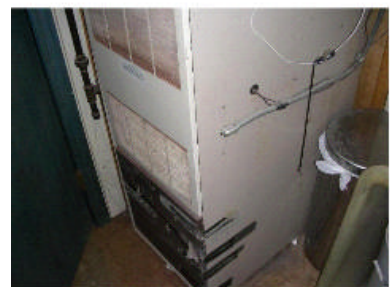
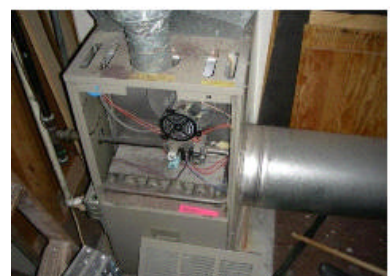
The 20+ year old Arcoaire services the laundry mat.

This furnace shows rust and corrosion, it appears fully depreciated and in need of replacing.

Furnace appears 15+- years old with normal aging.

This furnace probably has 5+- years of life left.

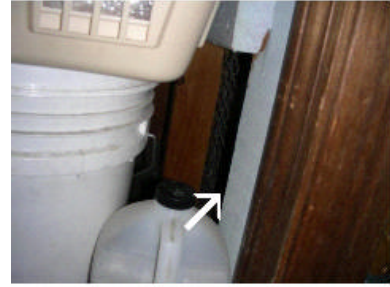
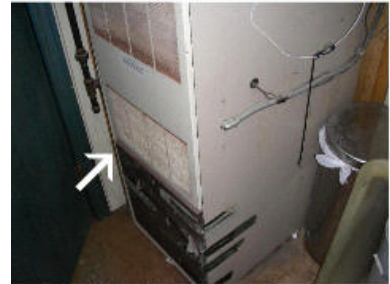
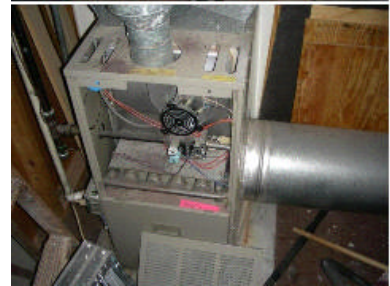
The laundry furnace is missing return air duct work.

Only a hole in the wall returns air to the furnace.  
Recommend a duct system be installed to properly return air to the furnace.

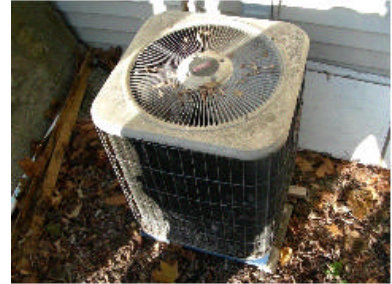
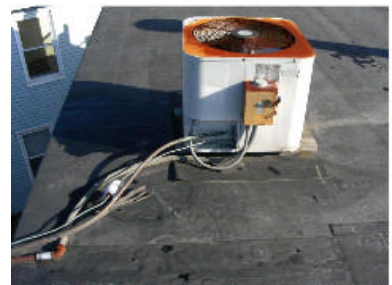
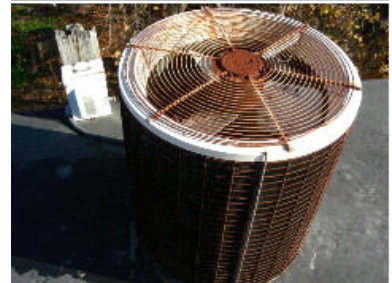
The A/C components appear fully depreciated, at the end of economic life. Recommend replacement.  
 Consult a qualified HVA/C technician.  
 All three exterior A/C components are seriously rusted, worn.

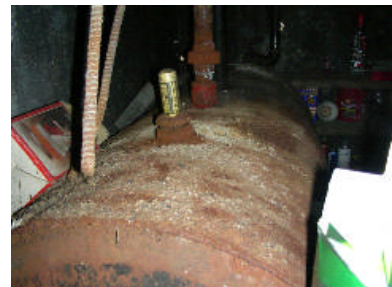
Observation: The steel oil tank is greatly deteriorated.  
 In my opinion, the oil tank is at end of service life. There is a potential for leakage and pollution hazards. Tanks rust from the inside outward and have a service life of 25-30 years.  
Recommendation: I advise that you contact an oil heat

contractor and request an estimate for the removal & disposal of the old tank along with the installation of a new tank.

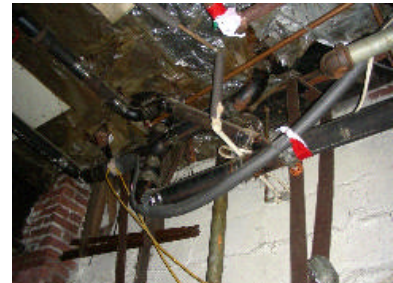
Visible drain waste vent pipes show moderate corrosion and some serious corrosion. System shows little in the way of capitol improvements.

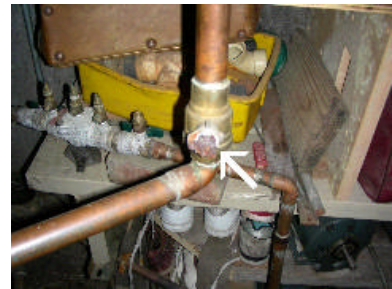
The building side main shut off has rooted away, needs repair.

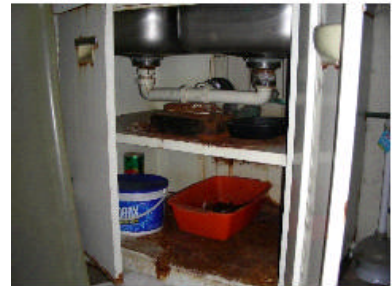
There are several sinks in the building that are leaking and show poor amateur repairs that need to be removed and extensively replaced.

Men' s bathroom in bowling area shows active leaks.

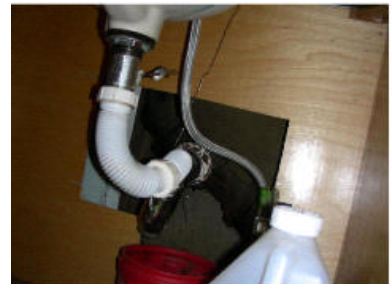
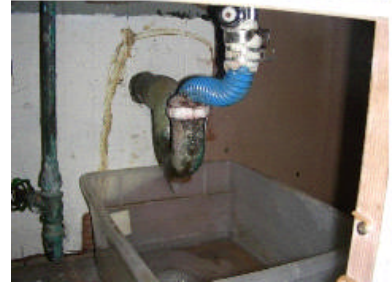
Women' s bathroom; sink is cracked and sink plumbing is in disrepair.

The laundry service' s sink also shows active leaks and poor amateur repairs, needs a major renovation. Consult a qualified Plumber.

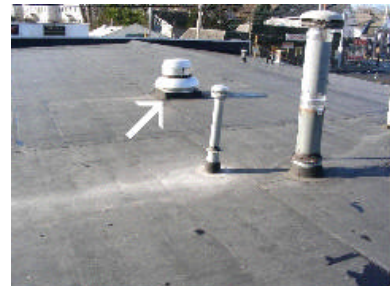
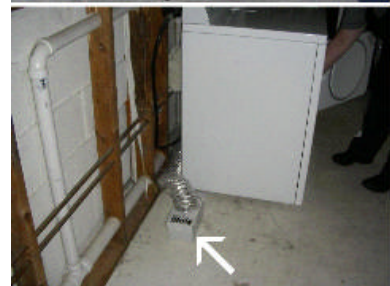
Dryer vent improperly exhausts into building creating unwanted dust accumulation indoors. Dryer should be connected to an exterior exhaust system.

Check and clean dryer vent system every 4 to 6 months to prevent over heating, which can be a fire hazard..

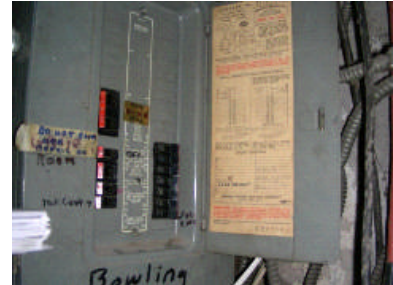
The bowling alley panel is a Federal Pacific "stab lok" breaker system that is known to be defective and unsafe. This panel is in need of replacing.

Observation - The home has a Federal Pacific brand electrical stab-loc circuit breaker panel  
Analysis: **HAZARD**  
**WARNING** - FP electrical panels are considered dangerous and subject to burnout as some of the breakers may not work, breakers become loose and may not provide protection against fire. This problem is associated with panels and circuit breakers manufactured in the 1970's and possibly extending to current equipment. Testing has shown that as many as 65% of the circuit breakers would malfunction creating a serious fire hazard as they fail to trip in response to an overload. Federal Pacific Electric was a Newark New Jersey based manufacture of electrical panels. Their panels (commonly known as FPE 'Stab-Loc') were installed in many area homes between early 1970 & mid 1980. Some entire developments, including apartments & townhouses were built with these panels. There are numerous problems associated with the 'Stab-Loc' panel, the most prevalent being the breakers are not reliable (they do not trip) when overloaded. A breaker is designed to turn the power off in case an overload occurs; this is the main safety feature of the 'breaker'. If a breaker fails to trip in an overloaded situation, the most likely result is a fire.

Other problems include the fact that breakers have on occasion fallen out when the front cover was removed (due to its design, it is difficult to remove the cover without tripping several breakers). Several models have a spring mounted bus bar; this design has since been prohibited.

Recommendation: I advise that an electrician reappraise the electrical service panel equipment as an urgent safety priority. Panel replacement can involve significant expense. The bottom line is simple; if your home currently has A FPE "Stab-Loc", replace it for the safety of you & your family!

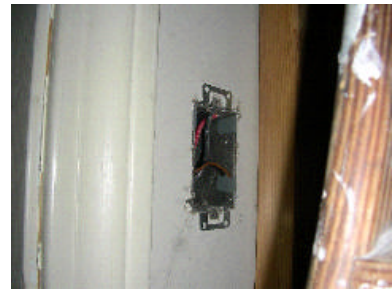
Branch wiring was difficult to observe due to obstructions. The dog groomer wiring is incomplete, the furnace room is missing lighting. A roughed in switch box was where installation stopped. Needs electrical repairs.

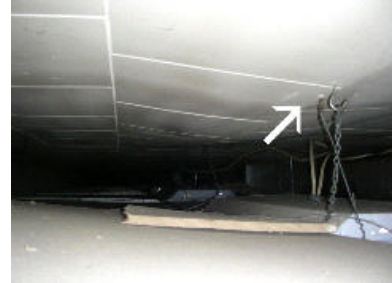
Recommend system be serviced by licensed electrician due to improper wiring as follows:  
The laundry light fixtures are improperly mounted to the ceiling tiles which are being pulled down.  
Unsafe Conditions.

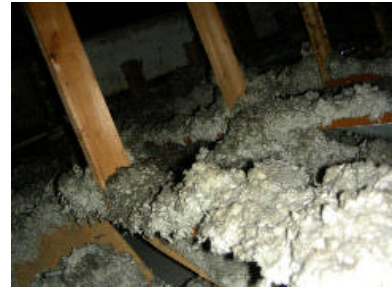
Water stains visible in one or more areas.  
 There is a variety of cosmetic conditions.  
 For the most part the store fronts appear satisfactory.  
 Extensive re-modeling will eventually be needed at the basement level.

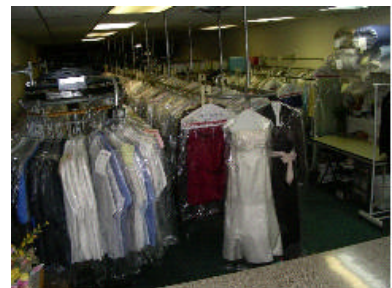
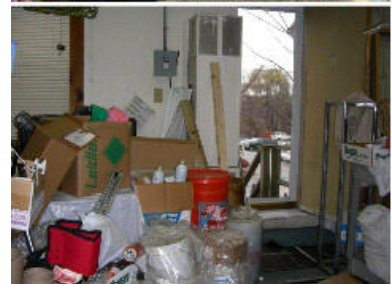
The laundry service shows wall to wall storage, some cluttered conditions, access to components was limited.

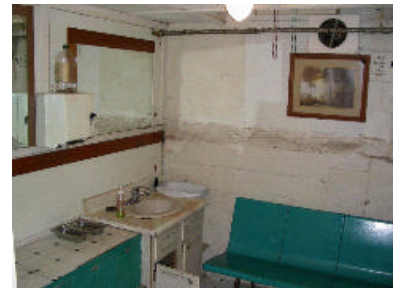
The first floor units bathrooms are for the most part in satisfactory condition. The basement bathrooms are old, worn and will require significant re-modeling.

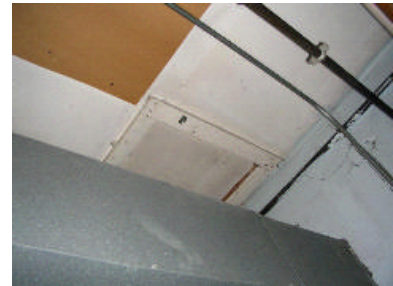
The only access hatch I found was blocked by a fresh air duct in the laundry service area.

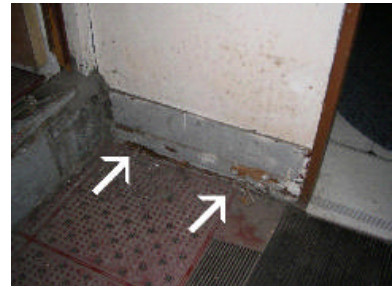
Visible evidence of a wood destroying insect infestation was observed as follows: Damage from wood destroying insects was noted in the following area(s): termite damage was observed in the basement bowling area lower wall. Also under the threshold of the north exit door from the dog groomer shop.

Inactive; no treatment recommended at this time.

Recommend a termite monitoring system be installed to guard against a re-infestation.  
Consult a Pest Control Operator.
